Int. J. Forest, Soil and Erosion, 2012 2 (3): 155-157

*Research Paper***Experimental research for riverbank restoration by using soil bioengineering**Lan Gu<sup>1</sup>, Jiarong Gao<sup>1,\*</sup>, Ying Liu<sup>1</sup>, Yue Wang<sup>1</sup>, Bintian Qian<sup>1</sup>,

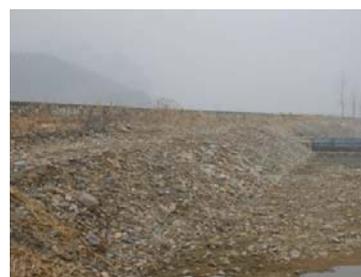
**Figure 1.** Experimental area before soil bioengineering construction in Huaijiu River

Experimental area is located at Huaijiu River, Huairou district of Beijing, China. Huairou district, between 40°14'~40°04' N and 116°17'~116°53' E, which is situated at northern Beijing, is known for being one of the most important water sources in the capital city earmarked for protection. Huaijiu River is a permanent stream with river slope range from 2.1‰ to 2.5‰. A length of bare riverbank treated with jackstone was selected to use soil bioengineering for restoration. Willow fence has been applied along the riverbank in the March of 2008. Before implementation of the project, this area was suffered from serious soil erosion. Organic matter content of soil is 12.203 g/kg. Few birds or aquatic were nearby (shown in Figure 1).

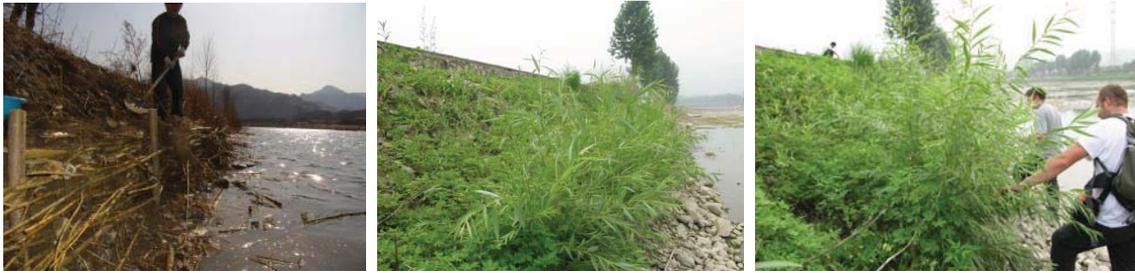
Figure 4. Experimental area by using wattle fence: the day of planting (left), 3 months after (middle) and 5.5 months after (right)

Restoration of a natural area includes planting of native species - grasses, wildflowers, plants, trees. This gives the natural ecosystem its building blocks towards recovering its natural state (Edson JL. et al. 1995). Figure 5 below shows the changes of wattle fence in the experimental area. By applying soil bioengineering technique, our experimental site has achieved environmental benefits of erosion control, wildlife habitat, water quality improvement and aesthetics. Birds, insect and many aquatic creatures come to live in this area. Organic matter content of soil is 17.360 g/kg three years after construction which indicates that vegetation on the slope can improve soil. Soil bioengineering helps to build an environmental friendly riverbank which can benefit not only the natural but also human beings.
