Int. J. Forest, Soil and Erosion, 2015 5 (1): 32-34

Short Communication

Root-fusion characteristic of eucalyptus trees block gully development

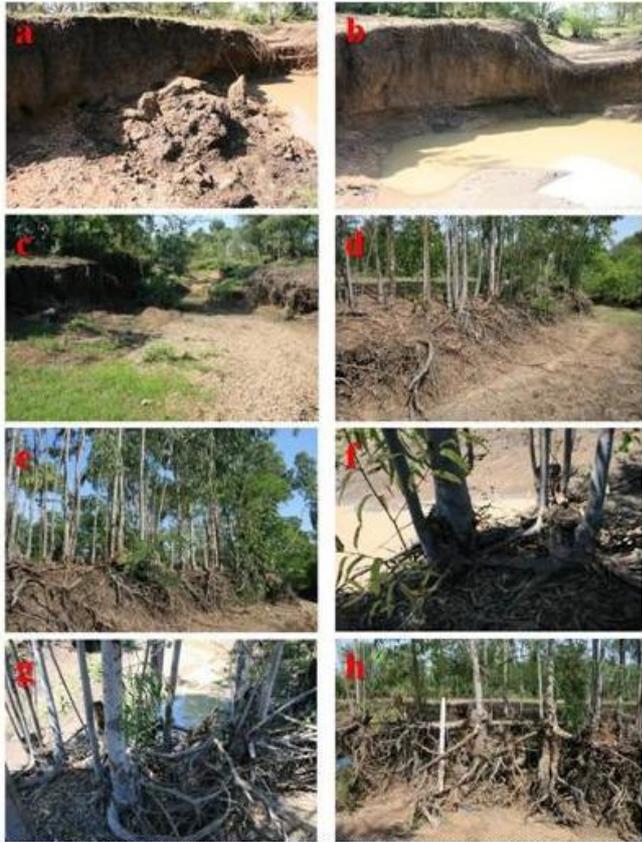
Figure 1. Field survey of Eucalyptus root system and its performance in blocking gully erosion development at Kokal village in Kisumu, western Kenya. Slumping of gully walls occur in the absence of Eucalyptus roots (a, b, c). Eucalyptus root system hold large soil mass preventing slumping of gully walls (c, d, e). Eucalyptus roots fused forming intimate mass of root system (f, g). Neighboring Eucalyptus supported adjacent tree whose roots were freed of soil by water erosion (h).

Eucalyptus trees the gully expanded by slumping of banks (Figure 1a and b). In contrast, the site where Eucalyptus trees (*E. citriodora*) grew along the bank of the stream did not result in gully expansion during the 3-year period. The root system of Eucalyptus trees held large soil mass, prevented the slumping of bank wall by water erosion, and blocked further development of the gully (Figure 1c, d and e).

The blocking of gully erosion was not by the root system of an individual Eucalyptus tree but by the root system networks between adjacent Eucalyptus trees. Their roots were connected intimately to each other by root fusions (Figure 1f and g). The network of roots among adjacent Eucalyptus trees by root fusion also supported the standing of the tree whose root system was completely free from soil. Besides, fused-root system seemed to supply the nutrients and water from the neighbors to the Eucalyptus tree whose root system was completely free from soil by soil erosion and which kept green as neighbors (Figure 1h). Recognizable aging and breakdown of root networks between adjacent trees were not observed during the survey period.

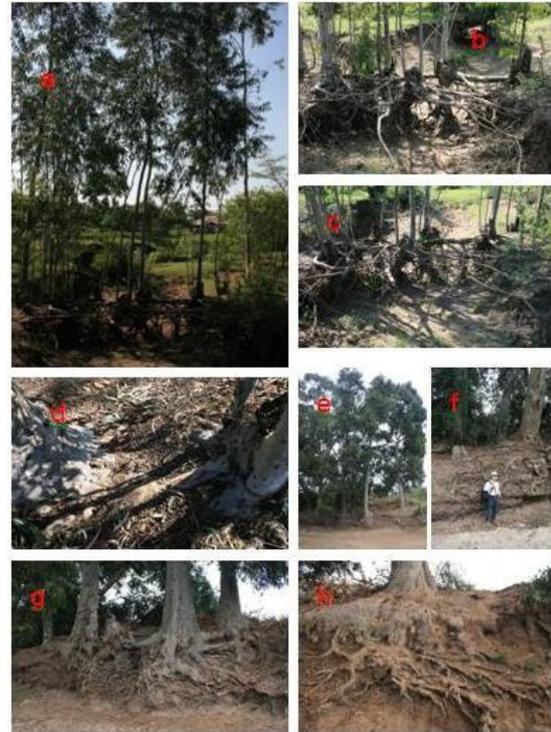
Figure 2. Field survey of Eucalyptus root-fusion in Kenya. Eucalyptus root-fusion phenomenon was also observed at Luanda village in Kisumu, western Kenya (a, b, c) and at Kenya Israel village in Machakos, eastern Kenya (d, e, f, g, h). Eucalyptus root-fusion takes different forms (g, h).

The root fusion was common occurrence for Eucalyptus trees and it was observed at Luanda village in Kisumu (Figure 2a, b and c). Any soil erosion was not observed at the site where the trees were grown along the border of upland fields (Figure 2d, e and f). Root fusion of Eucalyptus trees was also found at Kenya Israel village near Machakos town, eastern Kenya (Figure 2g and h). Gully erosion at the site reached to 3-m depth and dense root network of Eucalyptus trees completely blocked further gully expansion. Eucalyptus trees were nearly 20 m tall (Figure 2e) and root systems and root networks were denser than those observed in Kisumu (Figure 2f and g). Some roots were platy in appearance and held the soil completely inside the platy mass of roots (Figure 2h).
